**PRELIMINARY ASSESSMENT/  
VISUAL SITE INSPECTION**

**CLIFF DORION FACILITY  
(A.K.A. CLIFFS CONTAINER FACILITY)  
ROMEOVILLE, ILLINOIS  
ILD 000 768 481**

**FINAL REPORT**

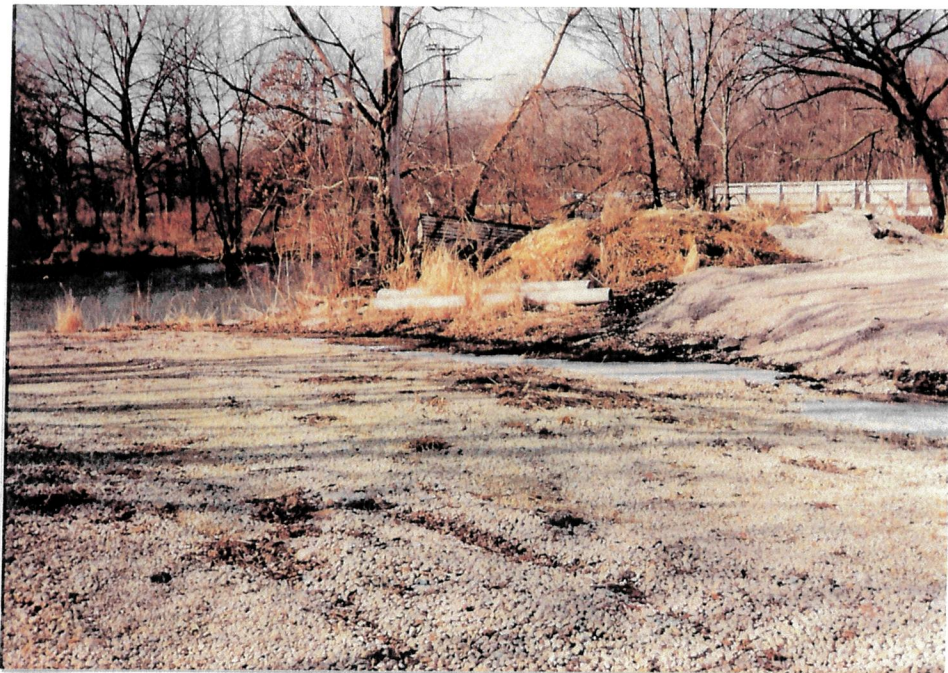
**8**

**Northern portion of the unlined trench that directs surface water runoff from SWMU 1 to the Des Plaines River.**

**Location: SWMU 1**  
**Date: February 4, 1993**
